HOME
report

Single Survey

Property address	24 Brodinch Road, Aberdeen, AB16 6QE
-------------------------	--

Date of inspection	12th April 2023
---------------------------	-----------------

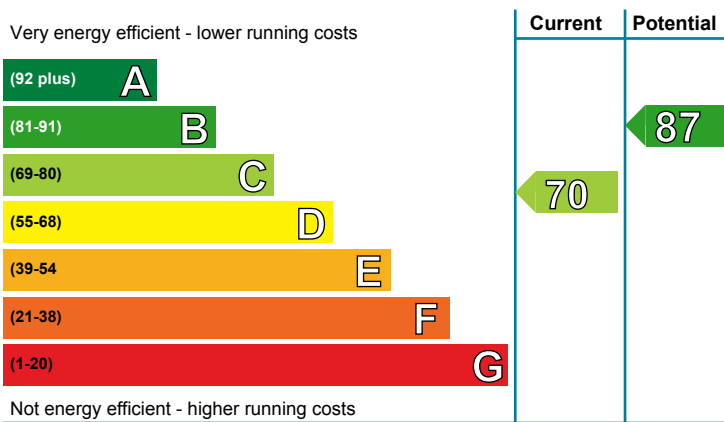
Energy Efficiency Rating

This graph shows the current efficiency of your home, taking into account both energy efficiency and fuel costs. The higher this rating, the lower your fuel bills are likely to be.

Your current rating is **band C (70)**. The average rating for EPCs in Scotland is **band D (61)**.

The potential rating shows the effect of undertaking all of the improvement measures listed within your recommendations report.

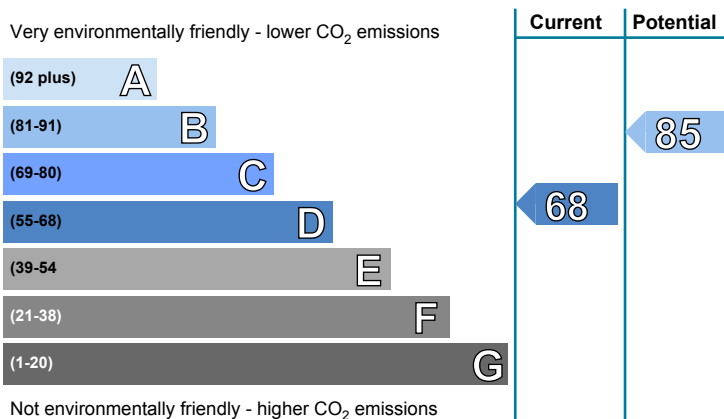
Environmental Impact (CO₂) Rating

This graph shows the effect of your home on the environment in terms of carbon dioxide (CO₂) emissions. The higher the rating, the less impact it has on the environment.
