HOME REPORT

2 STATION ROAD HATTON OF FINTRAY ABERDEEN AB21 0YE

ENERGY PERFORMANCE CERTIFICATE

SINGLE SURVEY

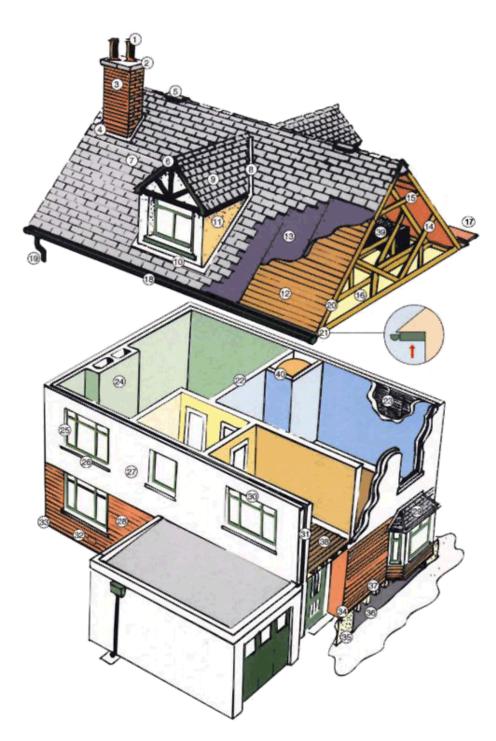
Sectional Diagram showing elements of a typical house

Reference may be made in this report to some or all of the above component parts of the property. This diagram may assist you in locating and understanding these items.

- 1) Chimney pots
- 2) Coping stone
- 3) Chimney head
- 4 Flashing
- 5 Ridge ventilation
- 6) Ridge board
- 7) Slates / tiles
- 8 Valley guttering
- 9 Dormer projection
- 10) Dormer flashing
- 11) Dormer cheeks
- (12) Sarking
- (13) Roof felt
- (14) Trusses
- 15) Collar
- (16) Insulation
- (17) Parapet gutter
- 18) Eaves guttering
- Rainwater downpipe
- 20) Verge boards/skews
- 21) Soffit boards
- 22) Partition wall
- 23) Lath / plaster
- 24) Chimney breast
- 25) Window pointing
- 6) Window sills
- 27) Rendering
- (28) Brickwork / pointing
- 29) Bay window projection
- 30 Lintels
- (31) Cavity walls / wall ties
- 32) Subfloor ventilator
- 33 Damp proof course
- 34) Base course
- (35) Foundations
- 36) Solum
- 37) Floor joists
- 38) Floorboards
- (39) Water tank
- 40) Hot water tank
